WELDING INSPECTION REPORT

Resident Engineer: Pursell, Gary **Report No:** WIR-002414 Address: 333 Burma Road **Date Inspected:** 02-May-2008

OSM Arrival Time: 700 **Project Name:** SAS Superstructure **OSM Departure Time:** 1700 **Prime Contractor:** American Bridge/Fluor Enterprises, a JV

34-0006 **Bridge No: Component: OBG** and Tower

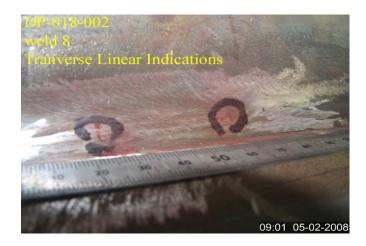
Bay 3

The Quality Assurance Inspector was informed by American Bridge/Fluor Representative Warren Buehler that ZPMC had identified four transverse cracks on weld 8 of deck panel DP-018-002. The Quality Assurance Inspector performed magnetic particle verification to the areas and observed the transverse linear indications identified by ZPMC Quality Control. Below are two digital photographs illustrating the linear indications.
